Real-scale investigation of the kinematic response of a rockfall protection embankment

Stéphane Lambert, A. Heymann, P. Gotteland, François Nicot

Stéphane Lambert, A. Heymann, P. Gotteland, François Nicot. Real-scale investigation of the kinematic response of a rockfall protection embankment. *Natural Hazards and Earth System Sciences*, 2014, 14 (5), pp.1269 - 1281. 10.5194/nhess-14-1269-2014 . hal-01012223

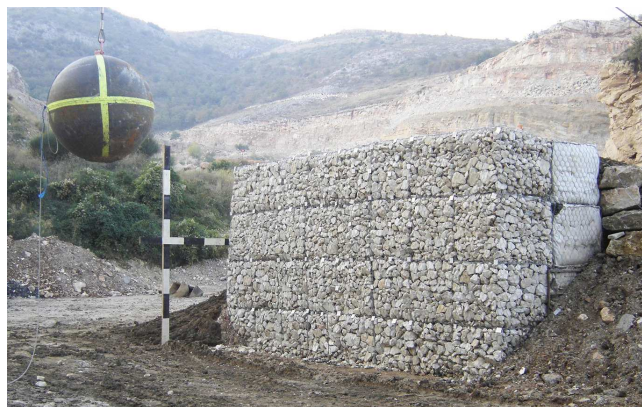
Figure 1. View of the tested embankment, showing the sandwich wall leaned against the levee and the hanging projectile.

The tested structure consists of a two-layered cellular sandwich wall leaned against a ground-compacted levee (Fig. 1). The wall is 4 m high, 8 m long and 2 m thick. The geocells consist of gabion cages made up of a hexagonal wire mesh with an 80×120 mm mesh, and a 2.7 mm diameter wire. Gabion cages are parallelepiped in shape, 3 m or 2 m long, subdivided into three or two 1 m^3 cubic parts, respectively.
